Iranian Journal of Medical Physics

Quality Control Monitoring of Medical Diagnostic X-Ray Units in Southern Tanzania

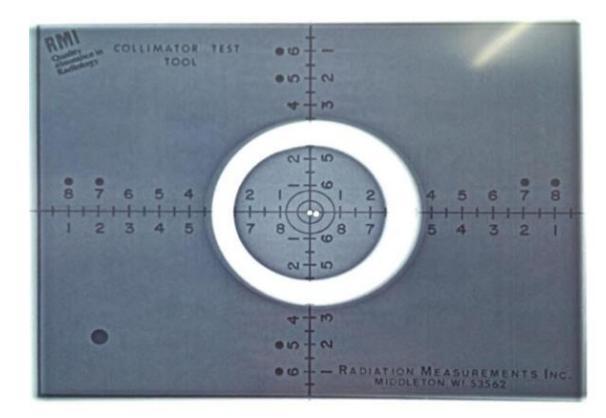
Figure 2. Typical radiograph from which beam limitation system is determined

From Figure 2, if the radiographic image of one lead ball is at the centre and the second ball intercepts the first cycle of the collimator test tool, then the beam is about 1.5° away from the perpendicular, if the image of one lead ball is at the centre while the other one intercept with the second cycle of collimator test tool, the misalignment is 3° . According to NCRP report number 99 of 1988, the X-ray beam misalignment should not exceed 3° [6, 18, 24].

Moreover, good collimation is considered if the Xray beam in the radiographic image falls within the frame of the marked rectangle in the collimator test tool. For instance, if the radiographic image shows the X-ray beam falls within the first mark in the rectangular frame of the collimator test tool, ± 1 cm on either side of the rectangular frame of the collimator test tool, the X-ray beam and the optical field are misaligned by 1% of the distance between X-ray table and X-ray tube [7]. According to AAPM report number 74 of 2002, the maximum allowable collimator misalignment is $\pm 2\%$ of the image to source distance [24, 28].

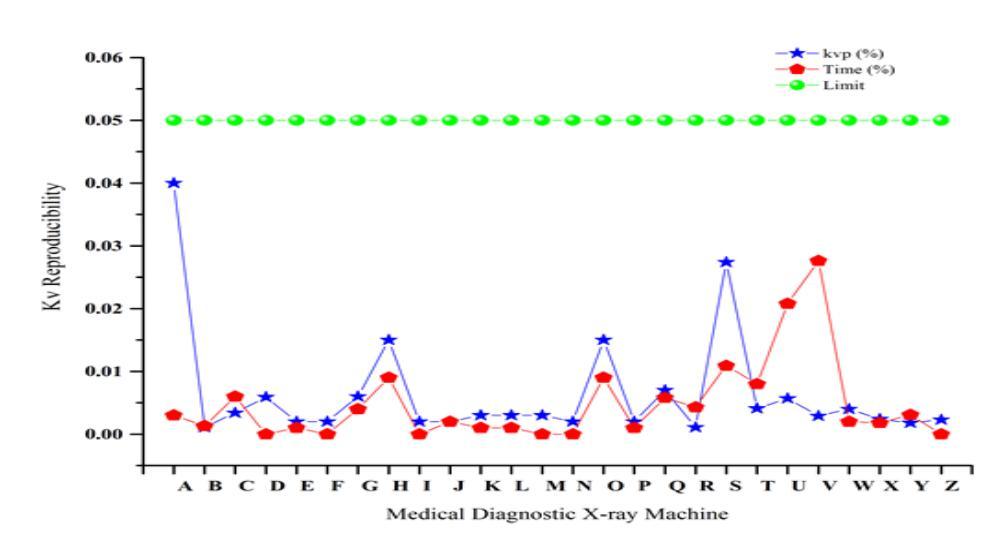
Figure 3. A plot of reproducibility against medical diagnostic X-ray machines from Mtwara, Lindi, and Ruvuma regions, Tanzania

The calculated values of *CV* for studied X-ray machines are presented in Table 2. As can be seen from Table 2, *CV* values ranged from 0.0011 to 0.04 and 0 to 0.0276 for accelerating tube potential and time, respectively. The average values for accelerating tube potential and time were found to be 0.0064 $\pm 2.26 \times 10^{-6}$ and $0.0047 \pm 3.31 \times 10^{-4}$, respectively. The observed variation from this compliance test is also evident in the reproducibility values presented in Figure 3.

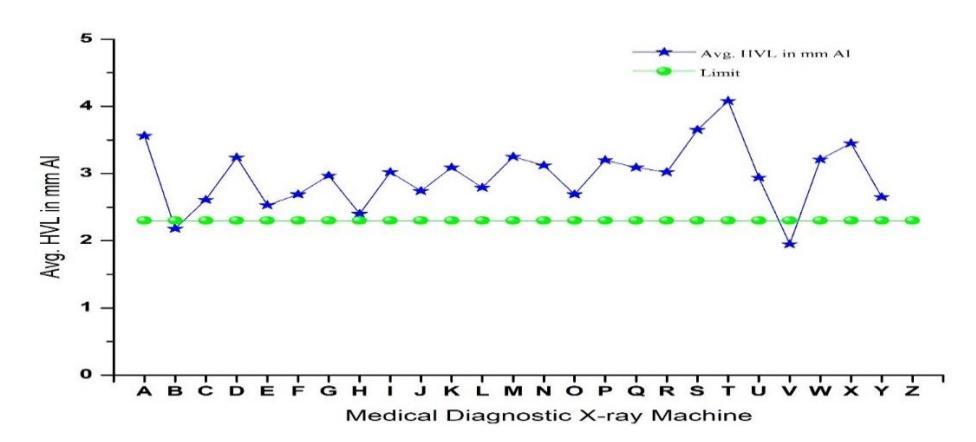
Figure 4. A plot of HVL measured at 80 kVp against medical diagnostic X-ray machines from Mtwara, Lindi, and Ruvuma regions, Tanzania

The calculated minimum, maximum and average HVL values of the studied X-ray machines are shown in Table 2. The results revealed that the calculated mean value of HVL at 80 kVp ranged from 1.95 (equipment manufactured in

2018) to 4.08 mm Al (equipment manufactured in 2019). As can be seen from Figure 4, 92% of the X-ray units have adequate beam filtration (mean HVL values) greater than recommended minimum HVL value of 2.3 mm Al [29].
